Equipment Compliance Certification and Inspection Solutions

**Focus on Safety C010 – ‘Irons’ with WECO hammer Unions**

**Swivels, Pup joints, Torque Valves, Integral joints**

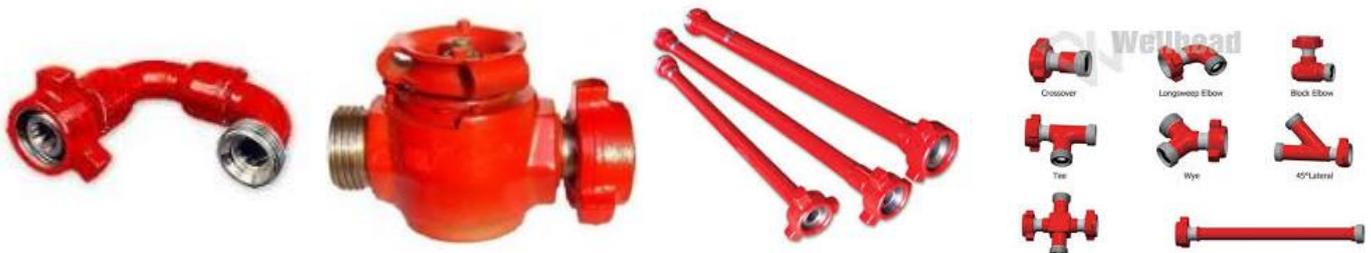
What are they

- API Temporary pressure piping with quick connect WECO ‘Hammer Unions’
- Used for a variety of operations on the Rig from Kill lines to cementing

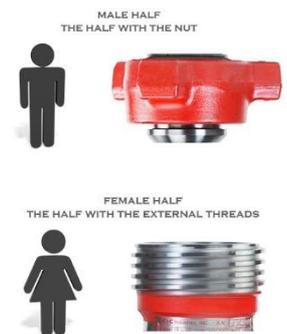
- WECO Hammer Unions, Special connection type for temporary high-pressure piping
- Common Types on the Rigs: **2" FIG 1502 & 3" 1003**
- 1002 Has been phased out from the Oilfields in recent years
- **602 and 1502 potential mis-match! – see below**

- Connection Mis-Match – Several incidents have occurred across the industry when the lower pressure ‘602’ female connection is paired with a ‘1502’ male Union – The 602 is slightly smaller, still fits well but cannot hold the pressure of the 1502.

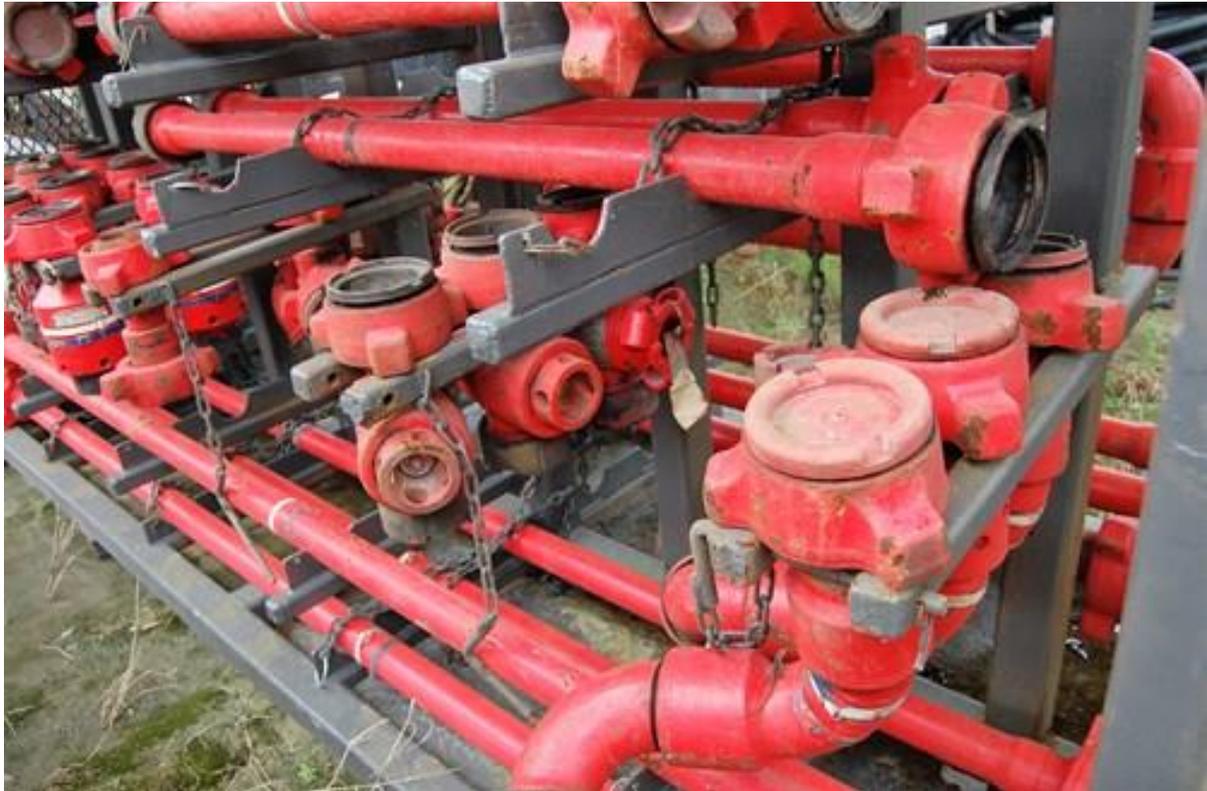
### Image of GOOD Storage for this critical Equipment: Notice the Thread protectors

Many Rigs store their 'Irons' in bins, threads exposed and damaged by the next item 'thrown' into the bin.. A Poor culture of care and maintenance that will need to be reversed to prevent a risk of incident.
